NASA TN D-8411

EFFECT OF LOW-VELOCITY IMPACT DAMAGE ON THE COMPRESSIVE STRENGTH OF GRAPHITE-EPOXY HAT-STIFFENED PANELS

*Marvin D. Rhodes, Jerry G. Williams,
and James H. Starnes, Jr.*

*Langley Research Center
Hampton, Va. 23665*

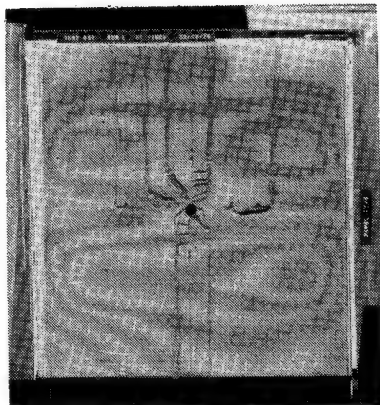
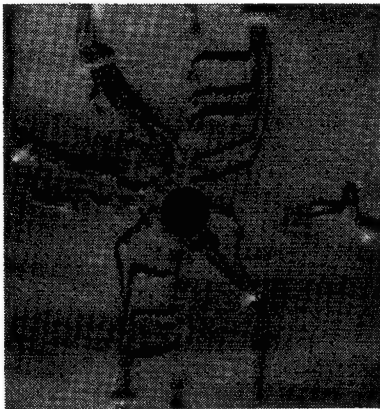
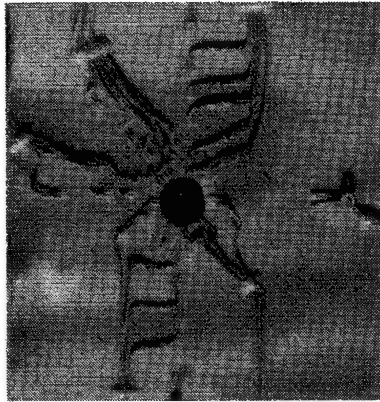
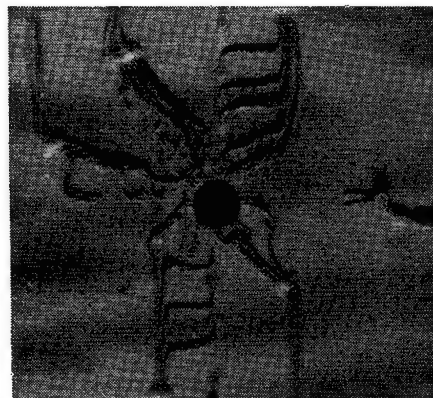
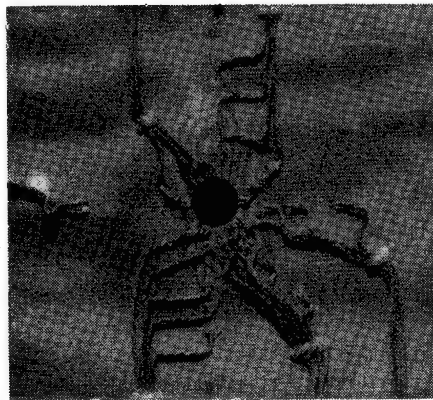
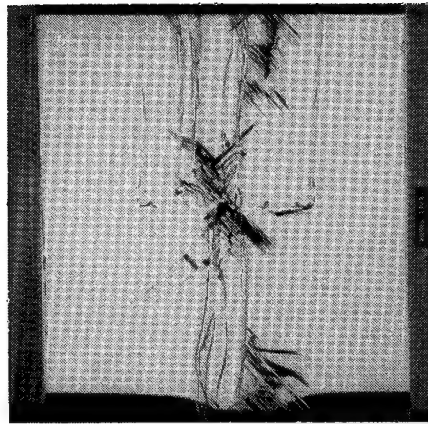
Figure 6.- Photographs of moiré-fringe patterns of panel B5 at several values of applied axial strain ϵ_a .
L-77-143

At applied strains near 0.0049 large changes in strain were recorded near the cutout and noticeable panel displacements began to develop in the vicinity of the cutout. Moiré-fringe patterns representing the normal displacement field near the cutout are shown in figure 6 for several values of applied strain. A representative moiré-fringe pattern for an applied strain of 0.0048 is shown in figure 6(a) and a closeup of the cutout region for this applied strain is shown in figure 6(b). At an applied strain of approximately 0.0049 a local buckling displacement field began to develop at the cutout edge about 60° counterclockwise from the loading axis. This displacement field was about 1.0 cm long for an applied strain of 0.0050 and is shown in figure 6(c). As the applied strain was increased, the extent of the displacement field increased to a length of about 1.8 cm for an applied strain of 0.0055 as shown in figure 6(d). At an applied strain of 0.0057, the displacement field had rotated counterclockwise to a position 90° from the loading axis (fig. 6(e)) and extended on both sides of the cutout. This displacement field extended about 2.5 cm on the left side and about 2.4 cm on the right side of the cutout which makes the total length of this displacement field approximately equal to the width of the 0° fibers in the skin under the stiffener. The local displacement field propagated across the panel (fig. 6(f)) at an applied strain of 0.0058 which indicates that the local behavior precipitated panel failure.

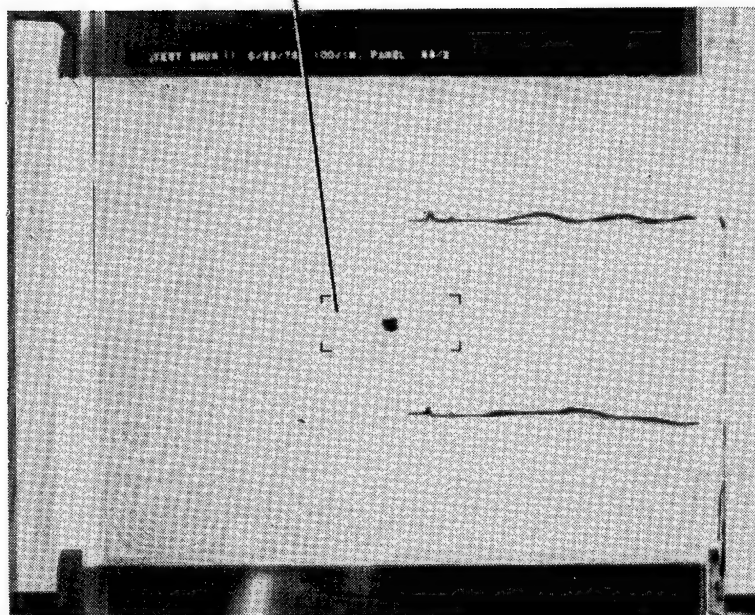
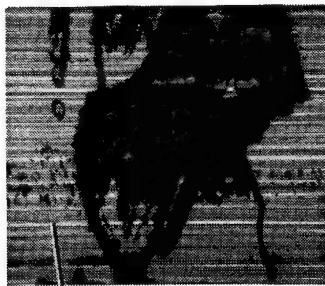
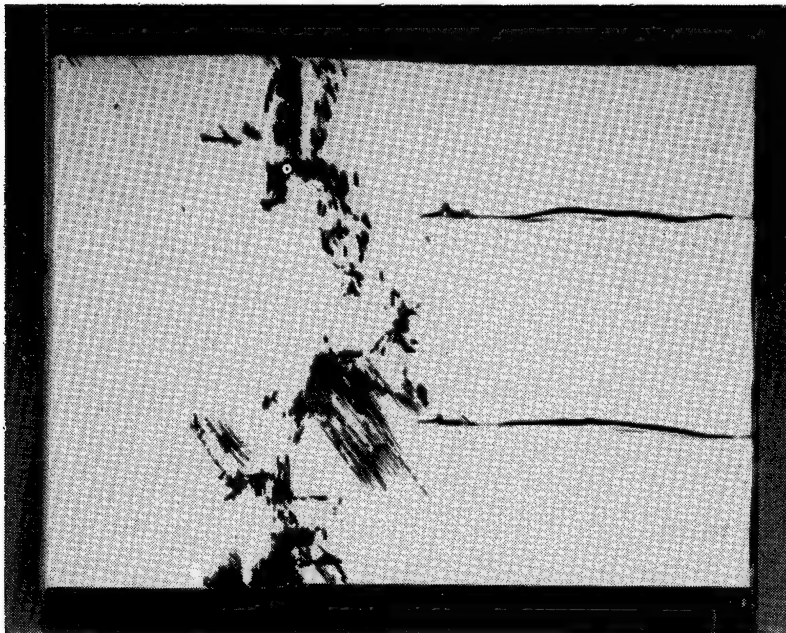
Figure 7.- Panel A4 (after impact in high-axial-stiffness region while at zero applied axial strain) before and after failure.

Photographs of the moiré-fringe pattern of panel A4 loaded prior to failure and of the failed panel are shown in figure 7. The moiré-fringe pattern (fig. 7(a)) is similar to that of the undamaged panel A1 (fig. 3(a)). The dark

spot in the center of the panel is the impact location where the paint has been removed for post impact inspection. Figure 7(b) indicates that the panel failure region is extensive and includes the impact location. The panel was inspected ultrasonically prior to failure, and a photograph of the oscilloscope record for the region in the vicinity of the impact location is shown in the insert of figure 7(a). The area represented by the insert is outlined on the photograph. The dark area shown in the insert indicates subsurface damage in the panel. This area is about 6.35 cm long and about as wide as the region beneath the hat which contains 0° plies. The results of tests on panels A4 and A5 were similar and both panels failed at applied strains near their design strain level (0.0034).

(a) Photograph of moiré-fringe pattern of buckled panel at applied axial strain of 0.0035. Insert shows region of subsurface damage.

(b) Panel after failure.

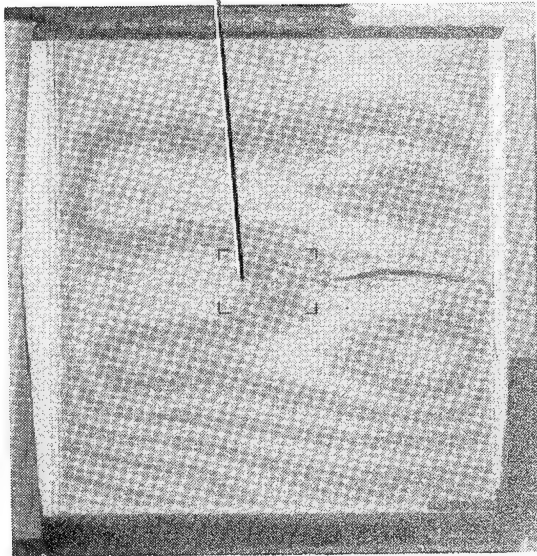
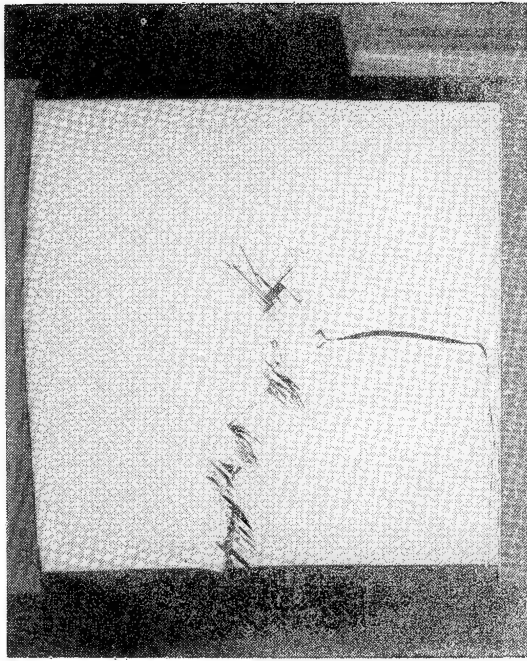
Figure 8.- Panel B6 (after impact in high-axial-stiffness region while at applied strain of 0.0003) before and after failure.

Photographs of the moiré-fringe pattern prior to failure and of the failed panel B6 are shown in figure 8. A small circular pattern in the region of impact was observed with the moiré-fringe technique indicating the presence of local damage. The development of this fringe pattern and an examination of the panel failure indicate that the impact damage precipitated the panel failure. Failure occurred at an applied strain of 0.0043 which is about 54 percent of the design value.

(a) Photograph of moiré-fringe pattern at applied axial strain of 0.0041 showing development of fringe pattern near point of impact. Insert shows region typical of subsurface damage in similar test panel.

(b) Panel after failure.

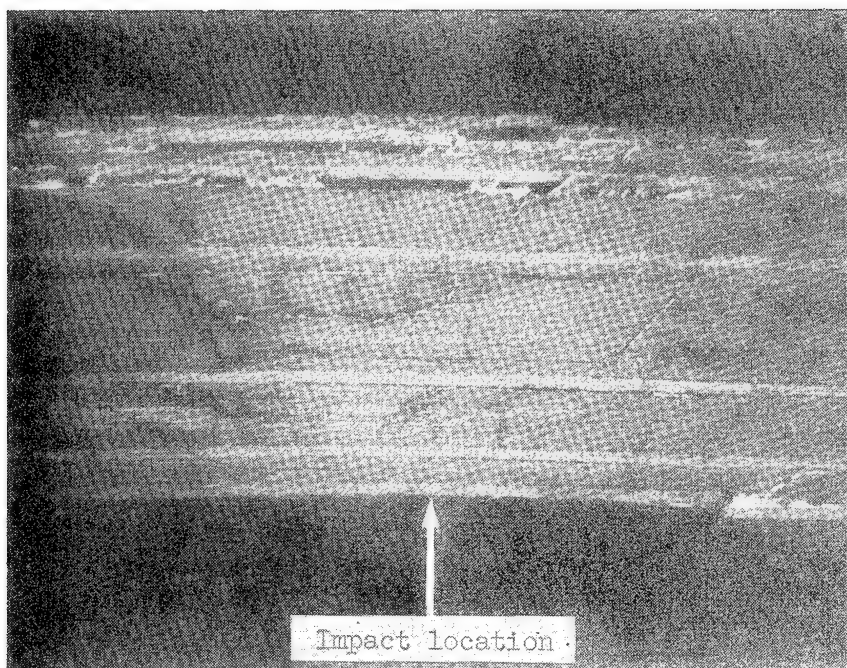
Figure 9.- Photomicrograph of cross section of high-axial-stiffness region of panel similar to B6 after being subjected to impact damage at zero applied axial strain.

The results of this investigation suggest that impact causes considerable delamination, and examination of the panel cross section showed that the delamination occurred primarily at the interface between the 0° and 45° plies (fig. 9). The discrete layers formed by delamination may not be midplane symmetric and, therefore, exhibit anisotropic coupling effects. The boundaries of these discrete layers are highly irregular (fig. 10) and are subjected to high interlaminar normal and shear stresses. Also, delamination reduces the local cross-sectional bending stiffness and causes locally eccentric loading which introduces transverse shear forces and moments not present in the undamaged panel. These local eccentric forces and anisotropic effects cause

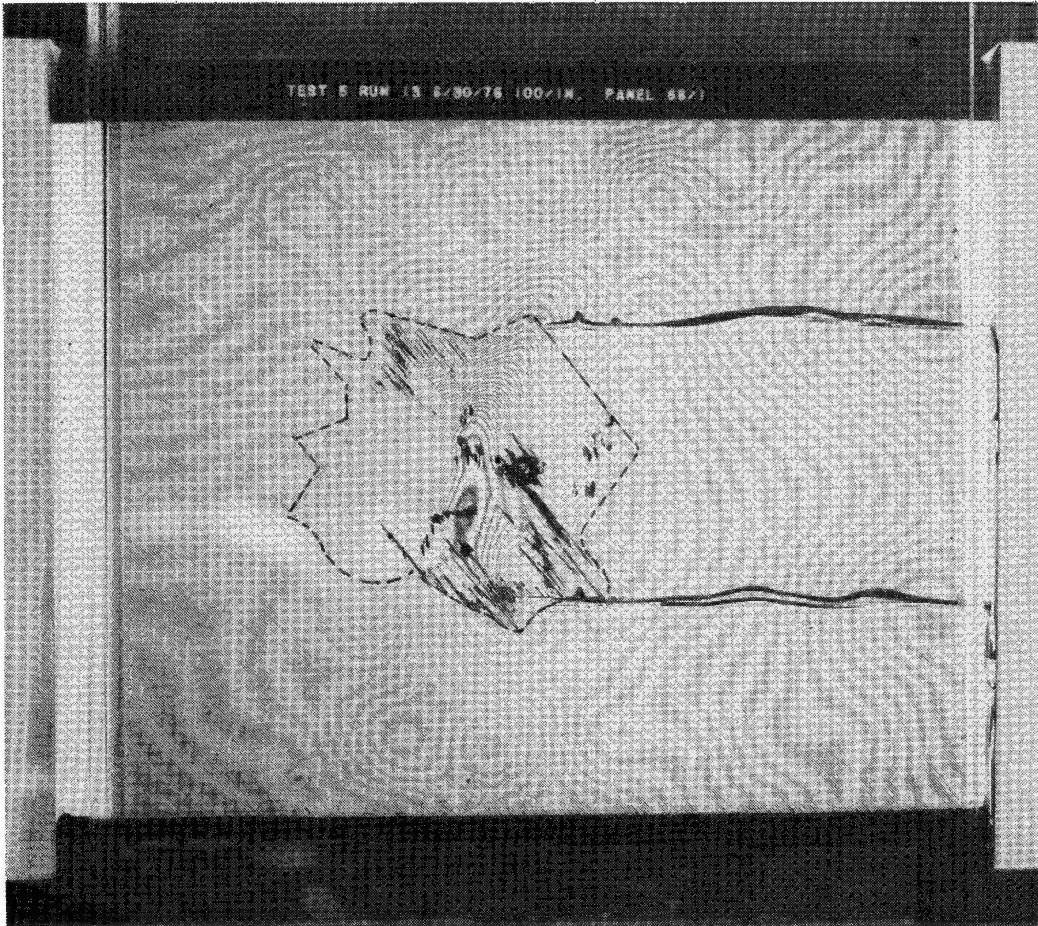
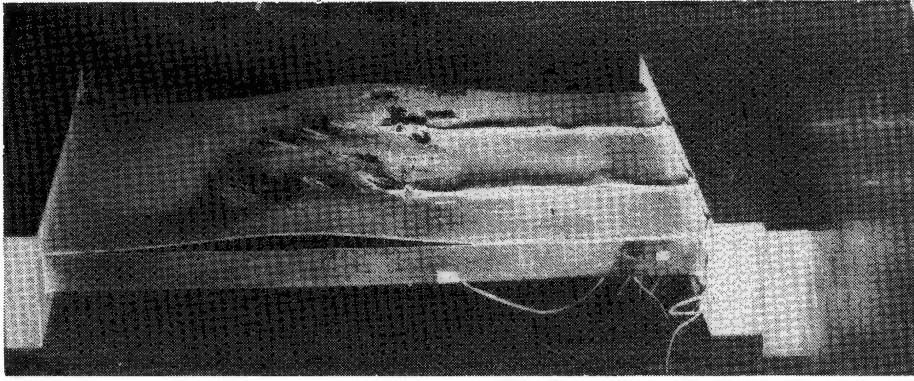
Figure 10.- Panel A3 (after impact in high-axial-stiffness region while at applied strain of 0.0034) before and after failure.

High axial strain at impact: Test panels A3, B7, and B8 were damaged by impact with a high axial load applied. (See table II.) Panels A3 and B7 which had an applied axial strain of 0.0034 and 0.0030, respectively, had a large region of visually detectable damage in the impact area. Instrumentation monitoring applied load indicated both panels had significant load reductions at impact due to loss in panel stiffness (table II). Both were subsequently loaded to failure to determine the panel residual strength. Panel A3 was ultrasonically inspected prior to the residual strength test and an extensive region of subsurface damage was detected. A photograph of the moiré-fringe pattern of the panel loaded prior to failure is shown in figure 10(a) where the subsurface-damage region is outlined. Even though the damage in panel A3 is extensive, it buckled at an applied strain near the design level and carried additional load after buckling similar to the undamaged panels. The panel failed in the region of the impact damage (fig. 10(b)) at an applied strain of 0.0037. Comparison of panel A3 with panels A4 and A5, all of which were designed for a load of 0.53 MN/m at an axial strain of 0.0034, indicates that

(a) Photograph of moiré-fringe pattern of buckled panel at applied axial strain of 0.0031.

(b) Panel after failure.

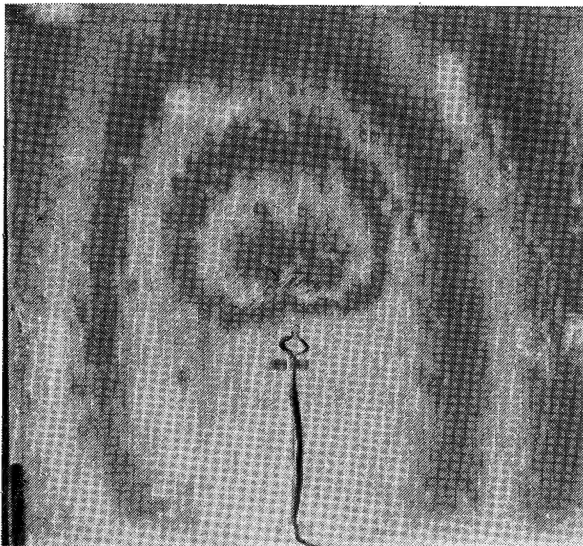
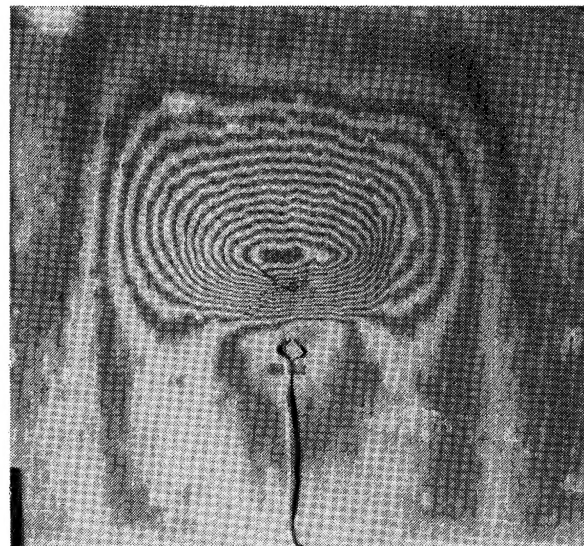
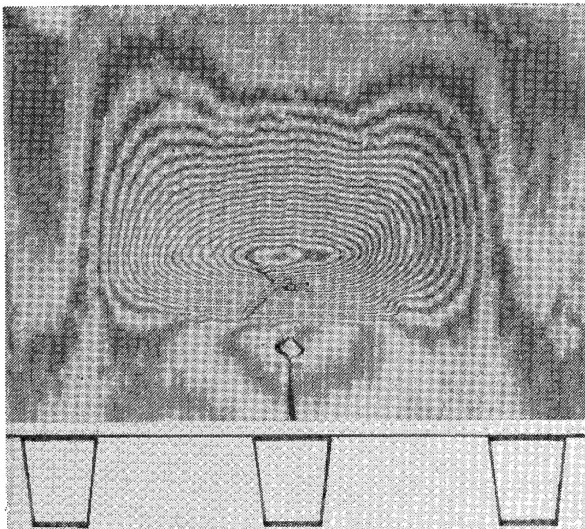
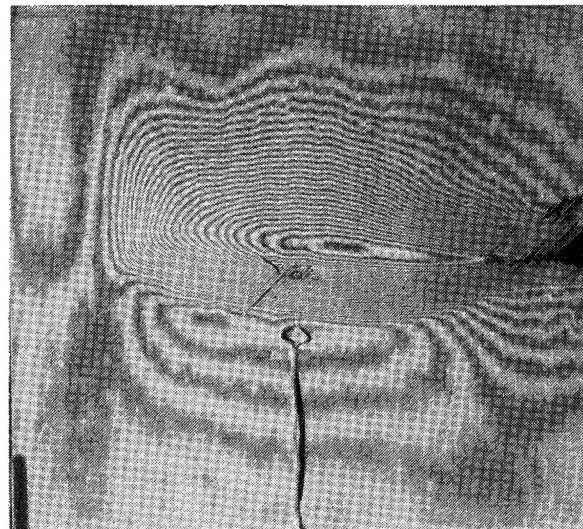
Figure 11.- Panel B7 (after impact in high-axial-stiffness region while at applied strain of 0.0030) before and after failure.

Several photographs of the moiré-fringe pattern taken during the residual strength test of panel B7 are shown in figure 11 along with a photograph of the failed panel. The moiré-fringe pattern shows considerable lateral deformation of the panel center, which may be due to impact-induced delamination or skin buckling. When the panel was damaged by impact, a reduction in applied load of 28.9 kN was measured. The 28.9-kN load reduction approximately corresponds to the load which the high-axial-stiffness region beneath the center stiffener is calculated to carry for an imposed strain of 0.0030. The panel failed at an applied strain of 0.0046 which is 58 percent of the design value.

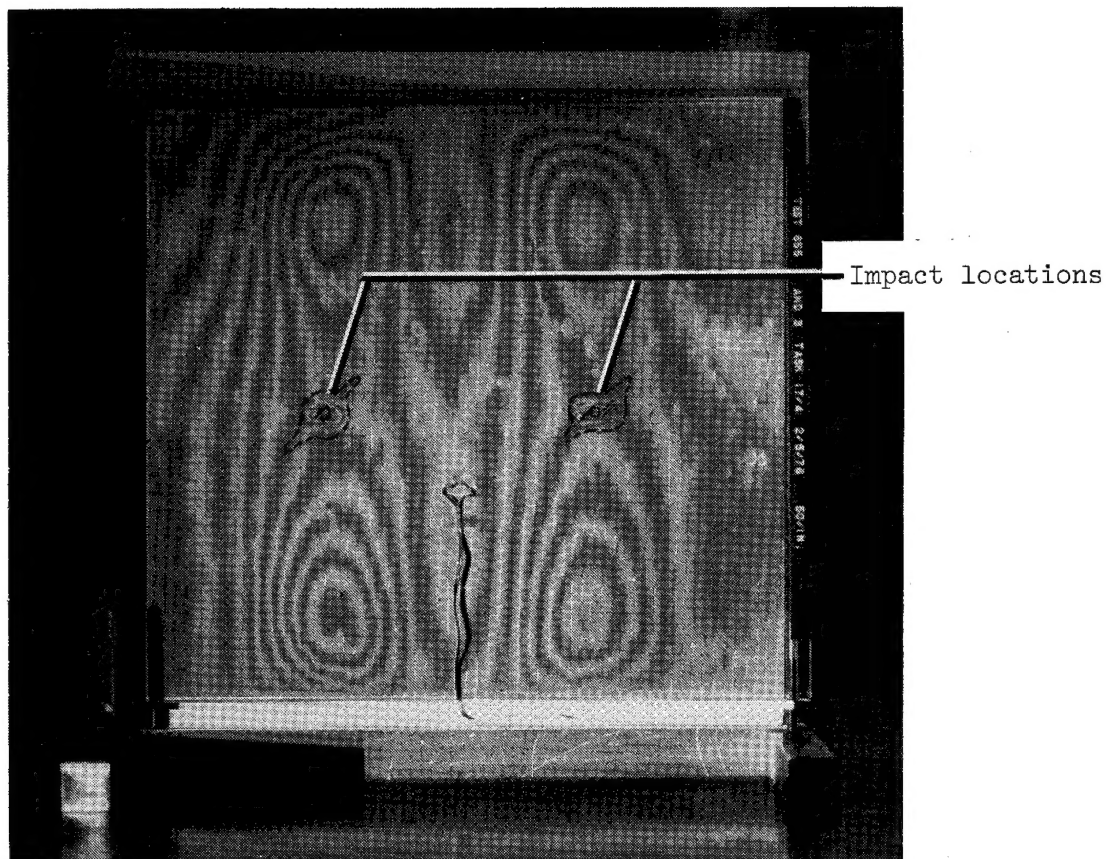
Figure 13.- Photograph of moiré-fringe pattern for panel B9 at applied axial strain of 0.0062 with impact damage at two locations in low-axial-stiffness region.

Impact damage in the low-axial-stiffness region.- In order to evaluate the effect of damage in the angle-ply, low-axial-stiffness region, panel B9 was damaged by impact in the skin region between stiffeners ($\pm 45^\circ$ for the design B panels). The panel was loaded to an applied axial strain of 0.0040 when impact occurred. (See table II.) No reduction in the applied load upon impact was observed and no increase in axial strain was noted in the gage near the point of impact. Although some local fiber failure and delamination was observed, the failure did not propagate. After impact the panel was loaded to an applied strain of 0.0054 without propagation of local damage. At this load the panel was damaged in the remaining $\pm 45^\circ$ skin region between stiffeners. (See table II.) No loss in load nor increase in strain near the point of impact was detected. This panel was subsequently loaded to an applied strain of 0.0062 at which a moiré-fringe pattern was observed in the end regions (see fig. 13) similar to that observed for the undamaged test panel. A local fringe pattern can be seen in the figure at each impact location.

Following this test the panel was inspected ultrasonically to evaluate the extent of the damaged region. The subsurface-damage region is outlined on the panel in figure 13. The two damaged regions are about the same size, which indicates that the magnitude of the applied strain had no apparent effect on the extent of local damage. These results indicate that impact damage in the regions having high axial stiffness is significantly more detrimental than it is in regions of low axial stiffness.
